AFWAL-TR-82-2121
Volume I

STRUCTURAL ELEMENT AND REAL BLADE IMPACT TESTING

UNIVERSITY OF DAYTON RESEARCH INSTITUTE
300 COLLEGE PARK AVENUE
DAYTON, OHIO 45469

FINAL REPORT FOR PERIOD OCTOBER 1977 - JUNE 1980

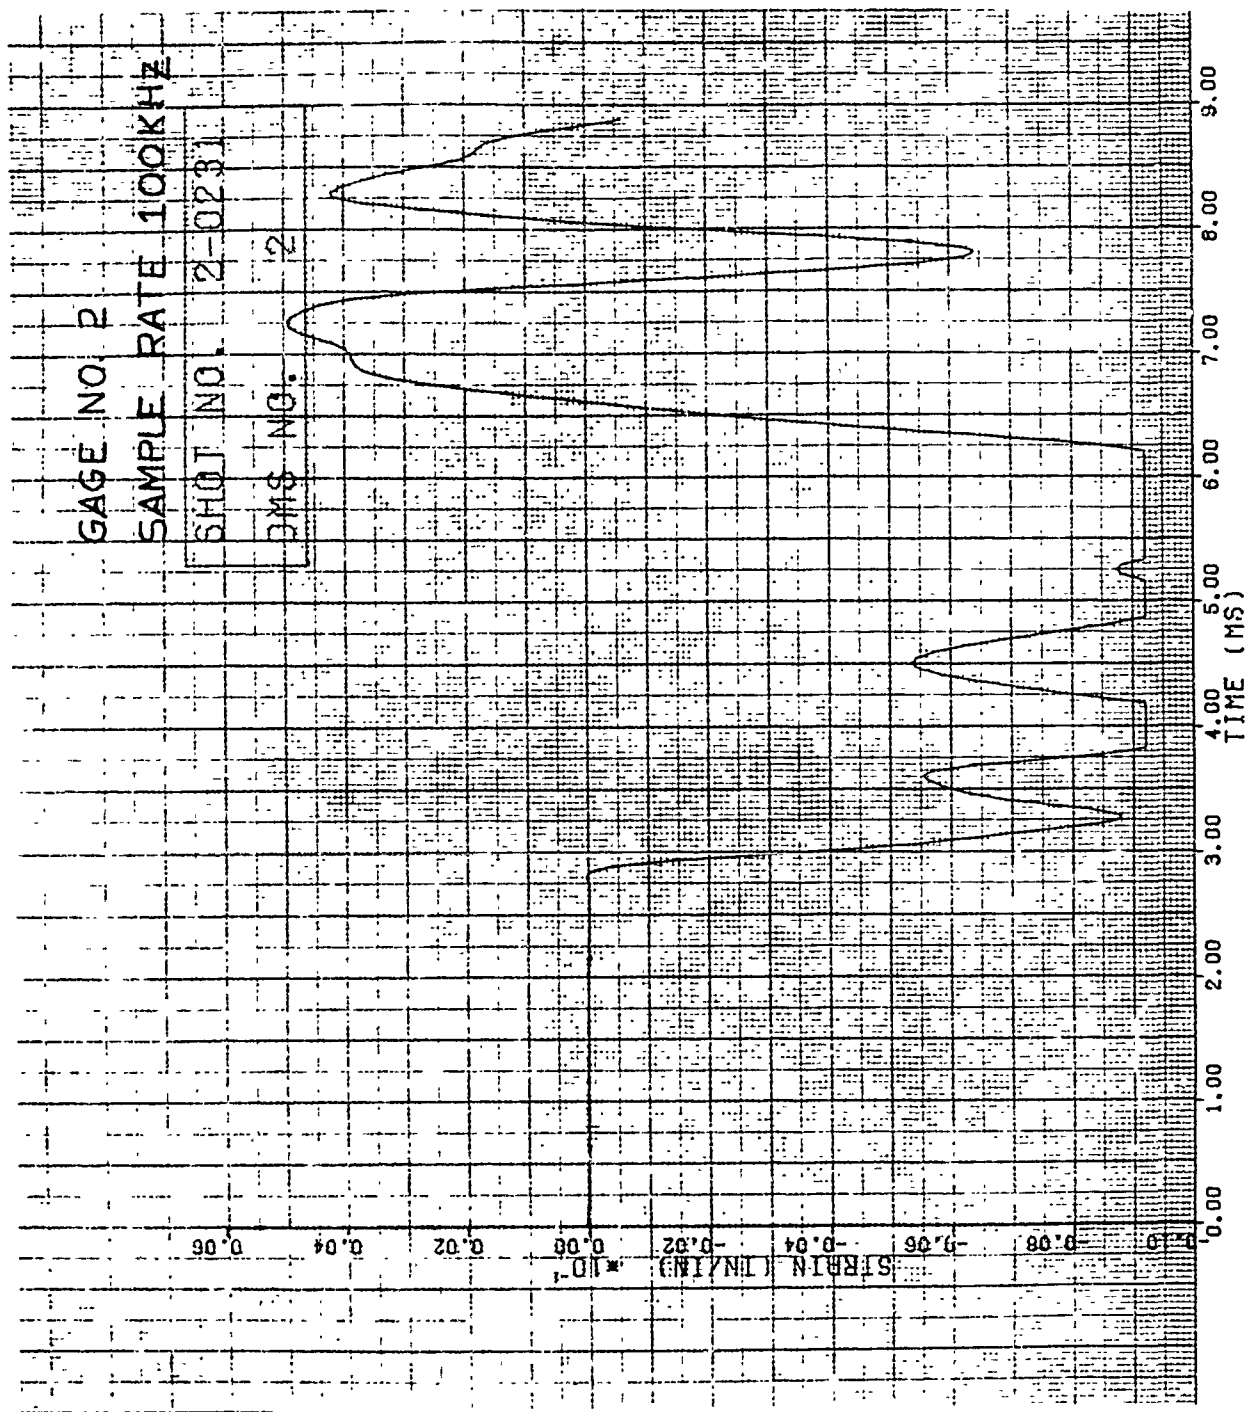
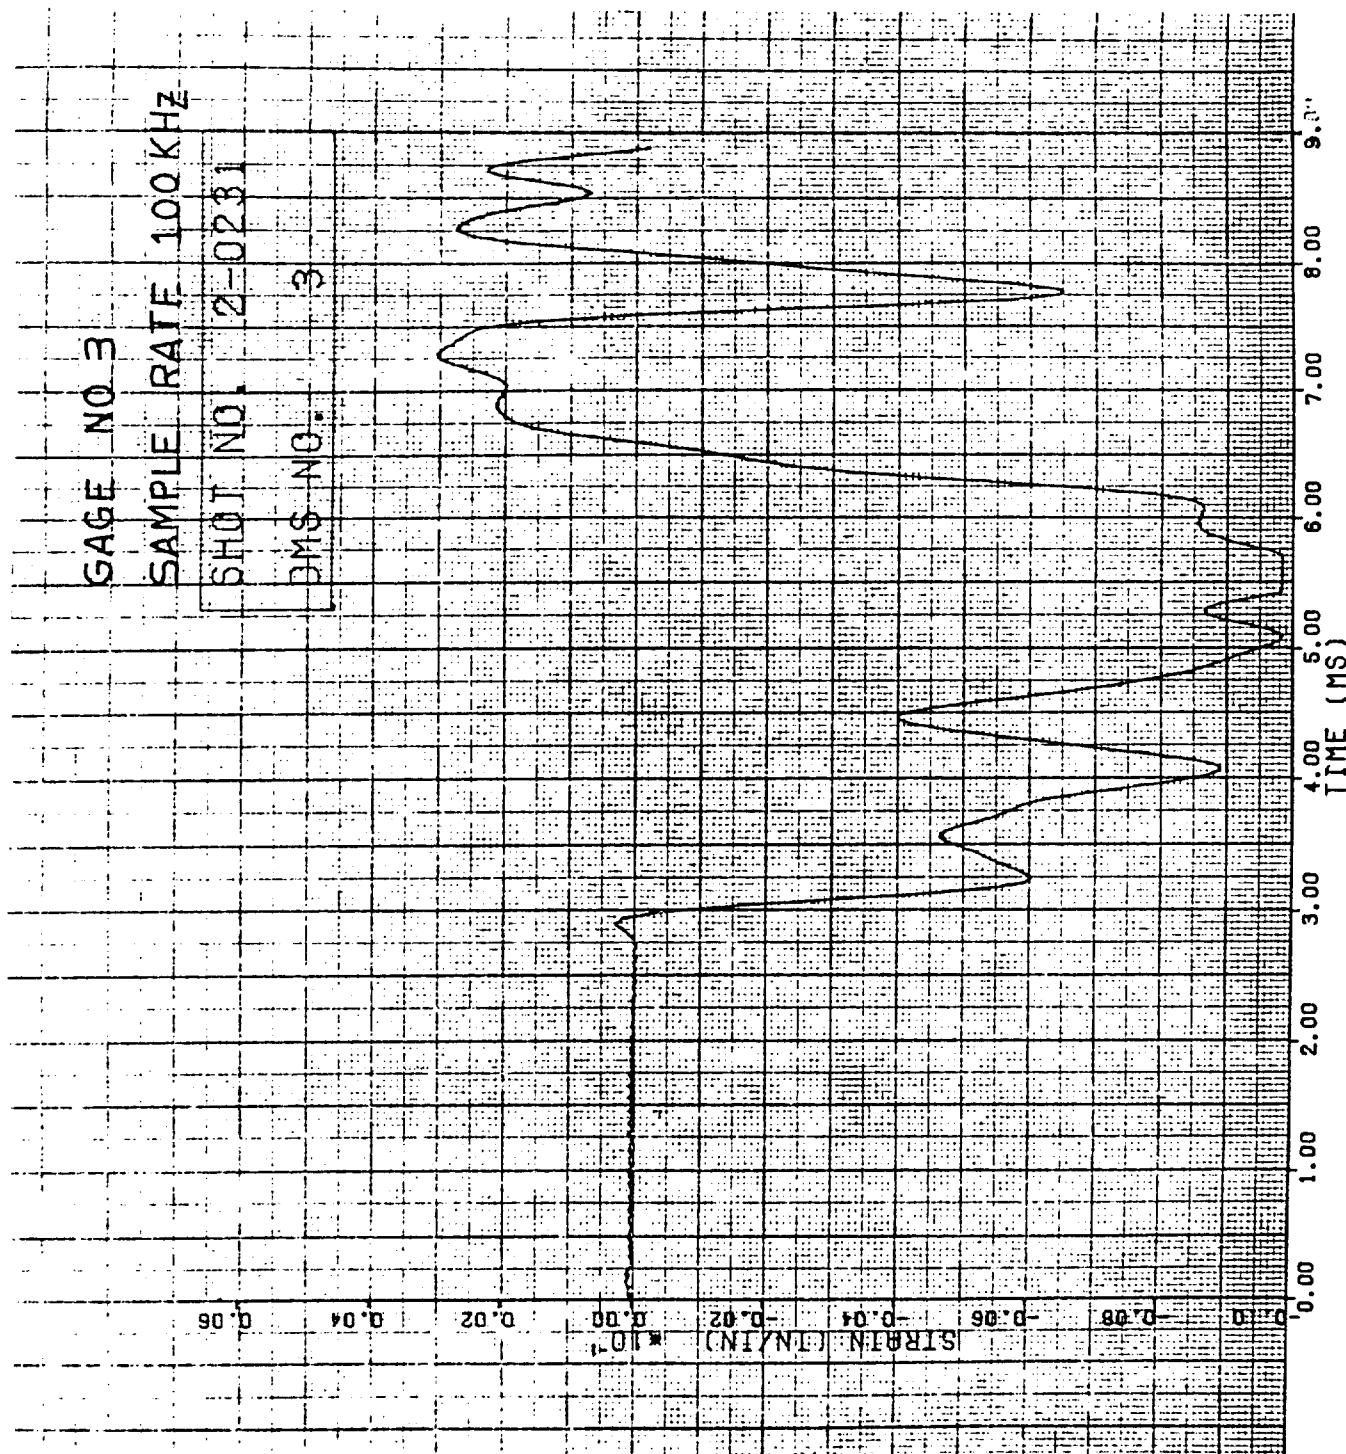
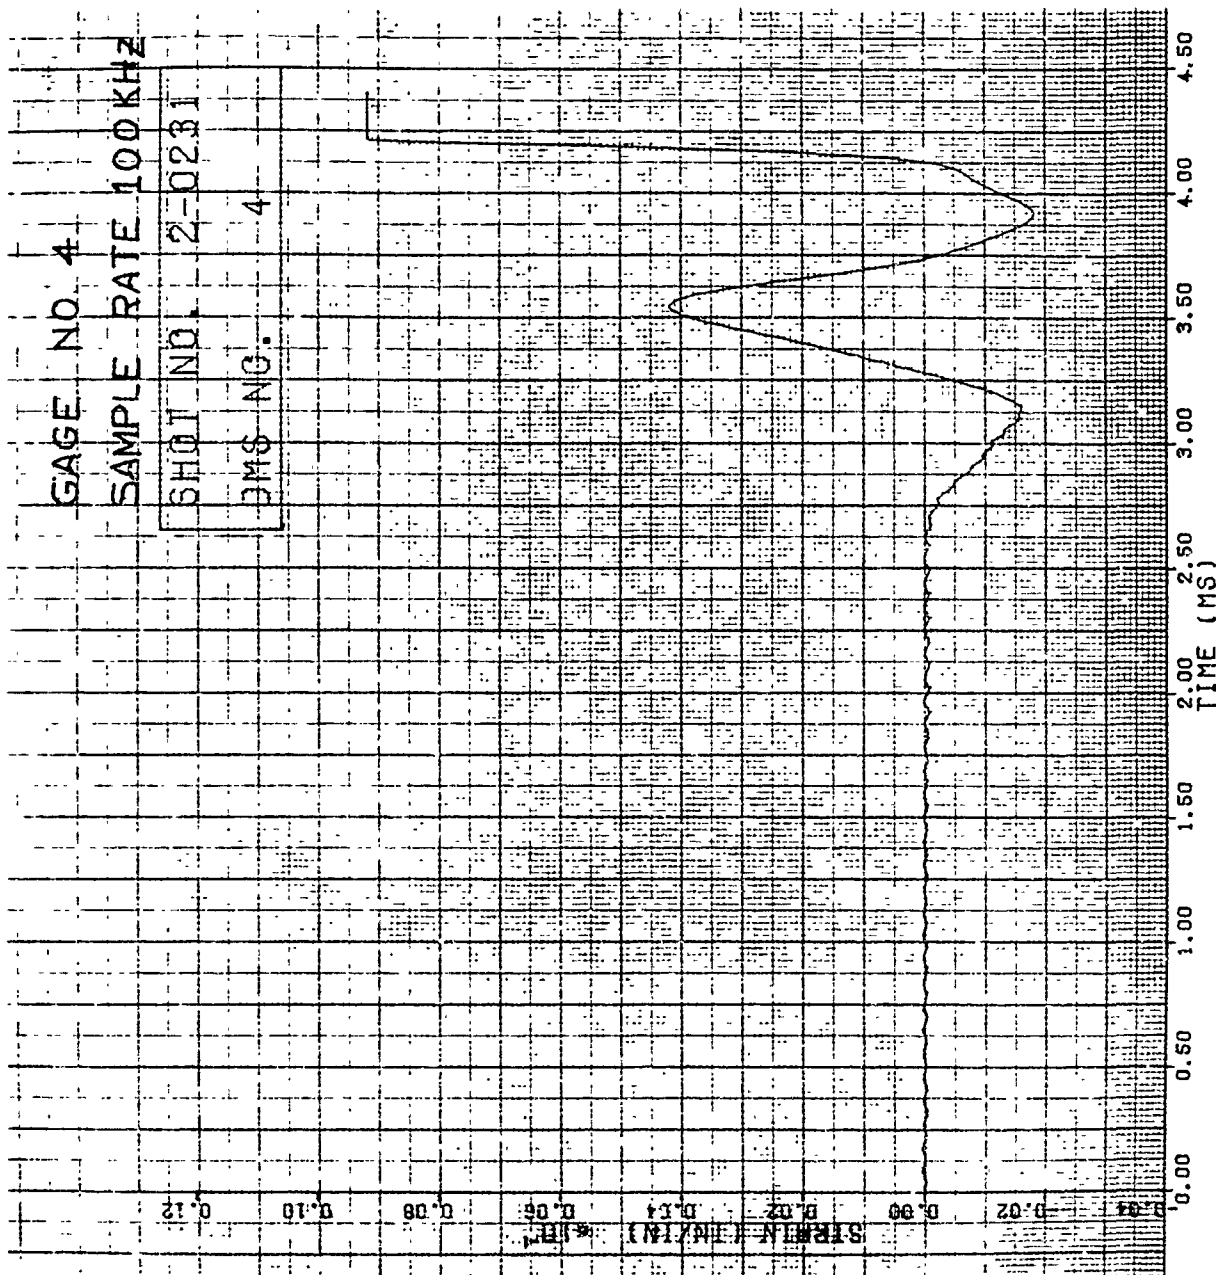
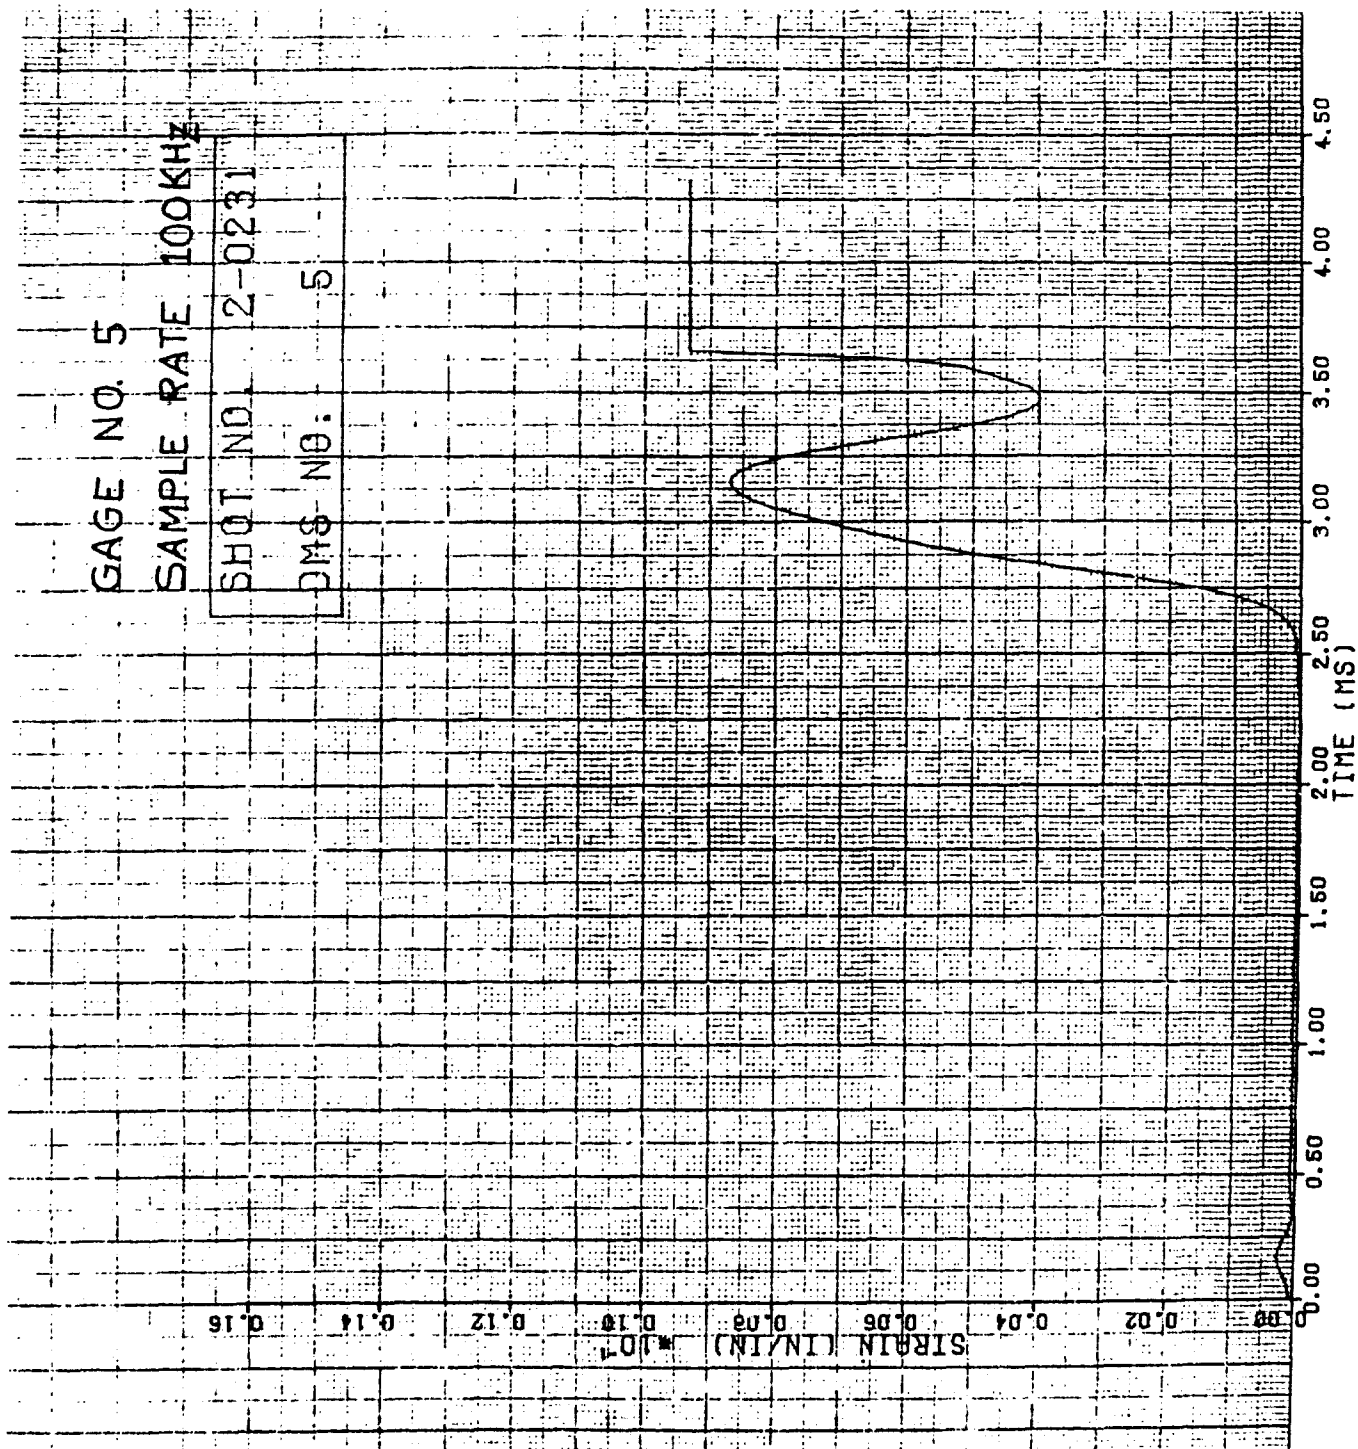
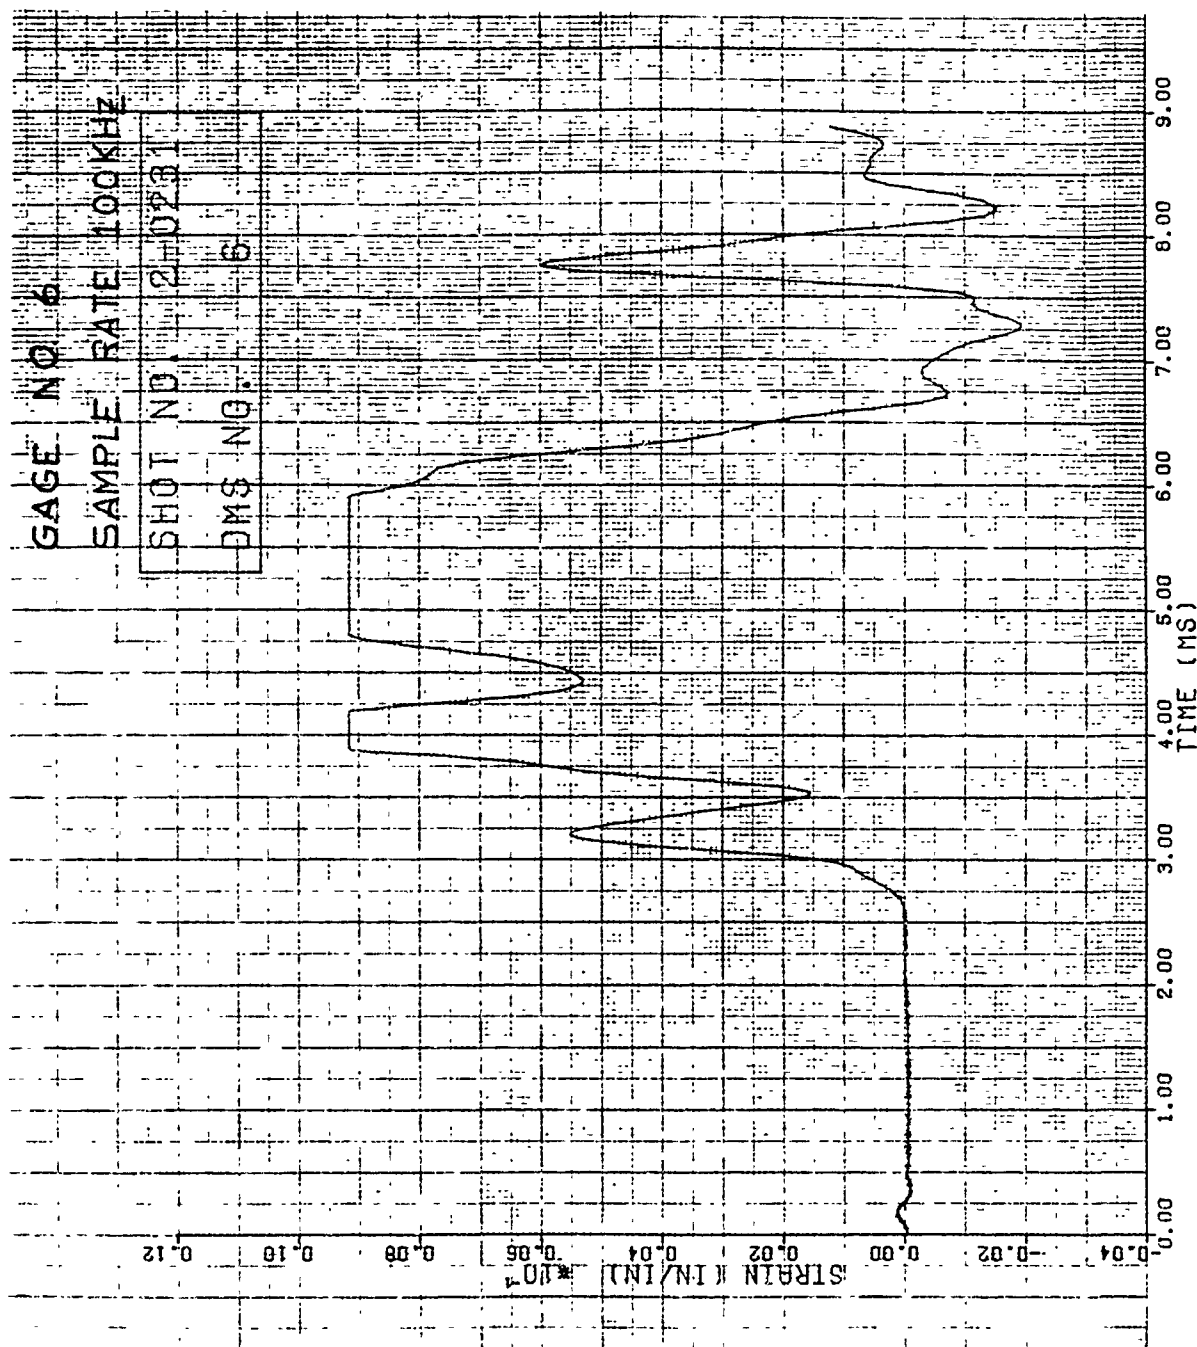
Four leading edge impacts of slab ice (7.62 cm diameter x 17.78 cm long) on F101 titanium Group 5B blades generated damage on only one blade (Shot 2-0231). The impact velocity for this shot at the 70 percent span location was 185 m/s and the impact mass was 75.8 grams. The angle of incidence for the impacts was 24.4 degrees. The blade tip was restrained as shown in Figure 5. The damage for Shot 2-0231 was in the form of bowing at the impact site 5.28 cm on the leading edge and 6.50 cm on the trailing edge.

The strain versus time curves for Shot 2-0231 are given in Figures 198 through 203. Tension is denoted by a positive strain and compression by a negative strain. The location of the strain gages is given in Figure 4A of Appendix A. Photographs of the damage of Shot 2-0231 are given in Figure 47B.

Figure 198. Strain of Shot 2-0231 for Gage #1.

Figure 199. Strain of Shot 2-0231 for Gage #2.

Figure 200. Strain of Shot 2-0231 for Gage #3.

Figure 201. Strain of Shot 2-0231 for Gage #4.

Figure 202. Strain of Shot 2-0231 for Gage #5.

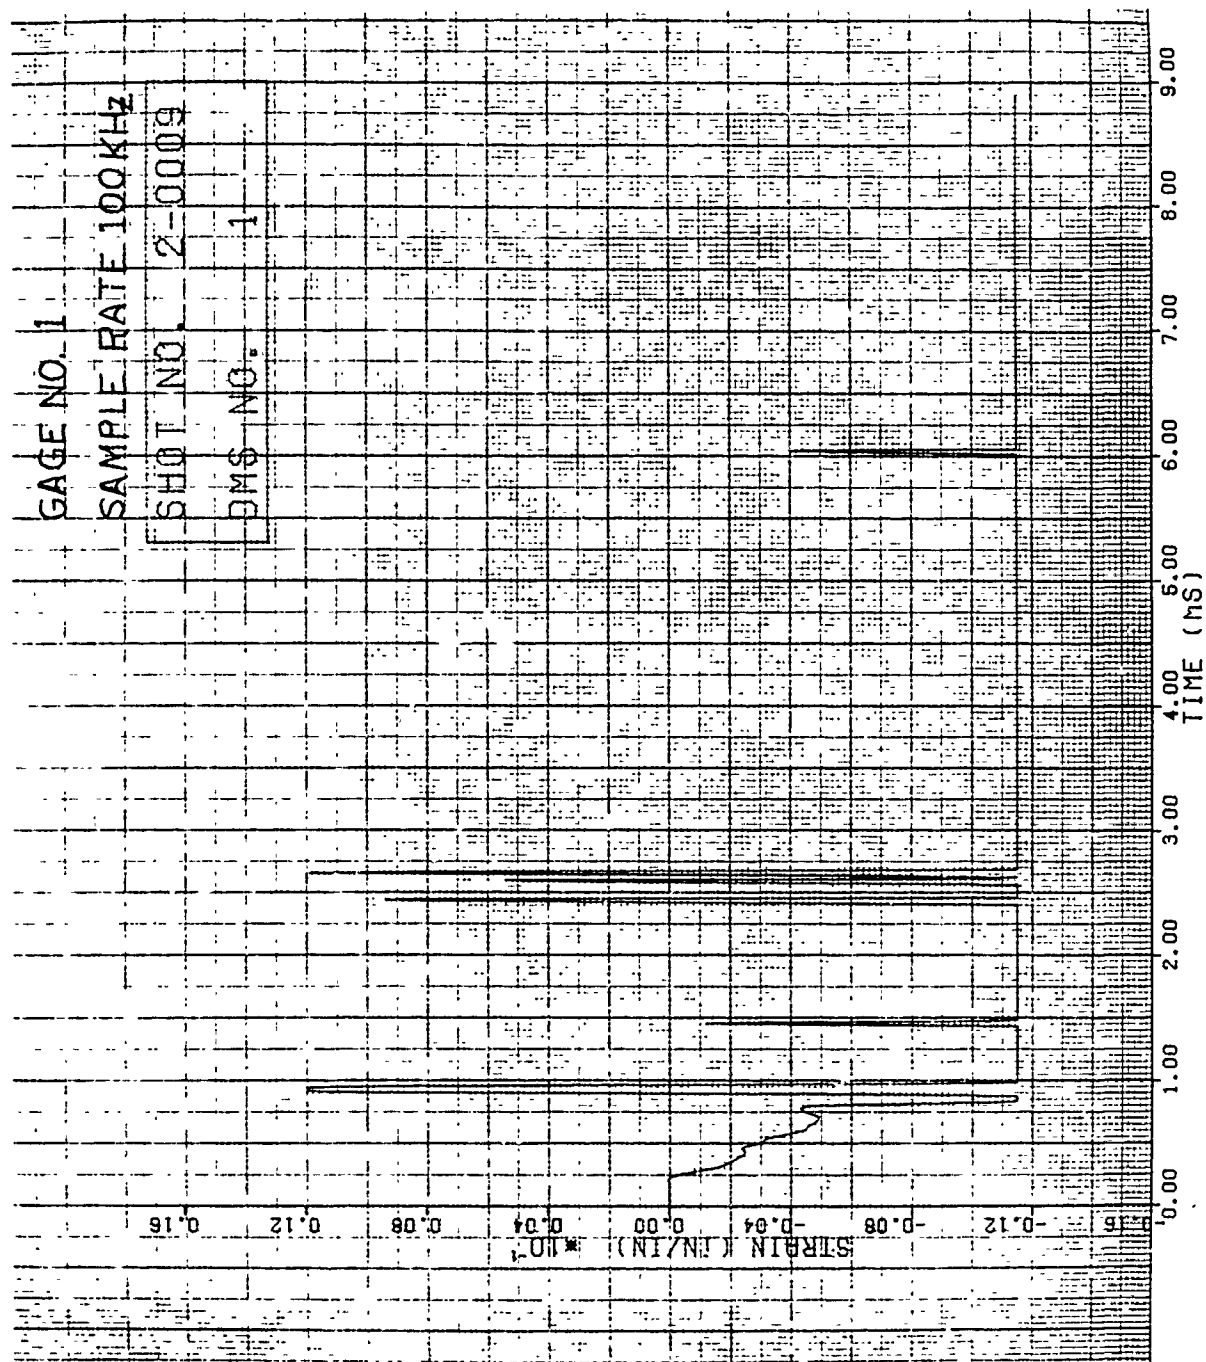
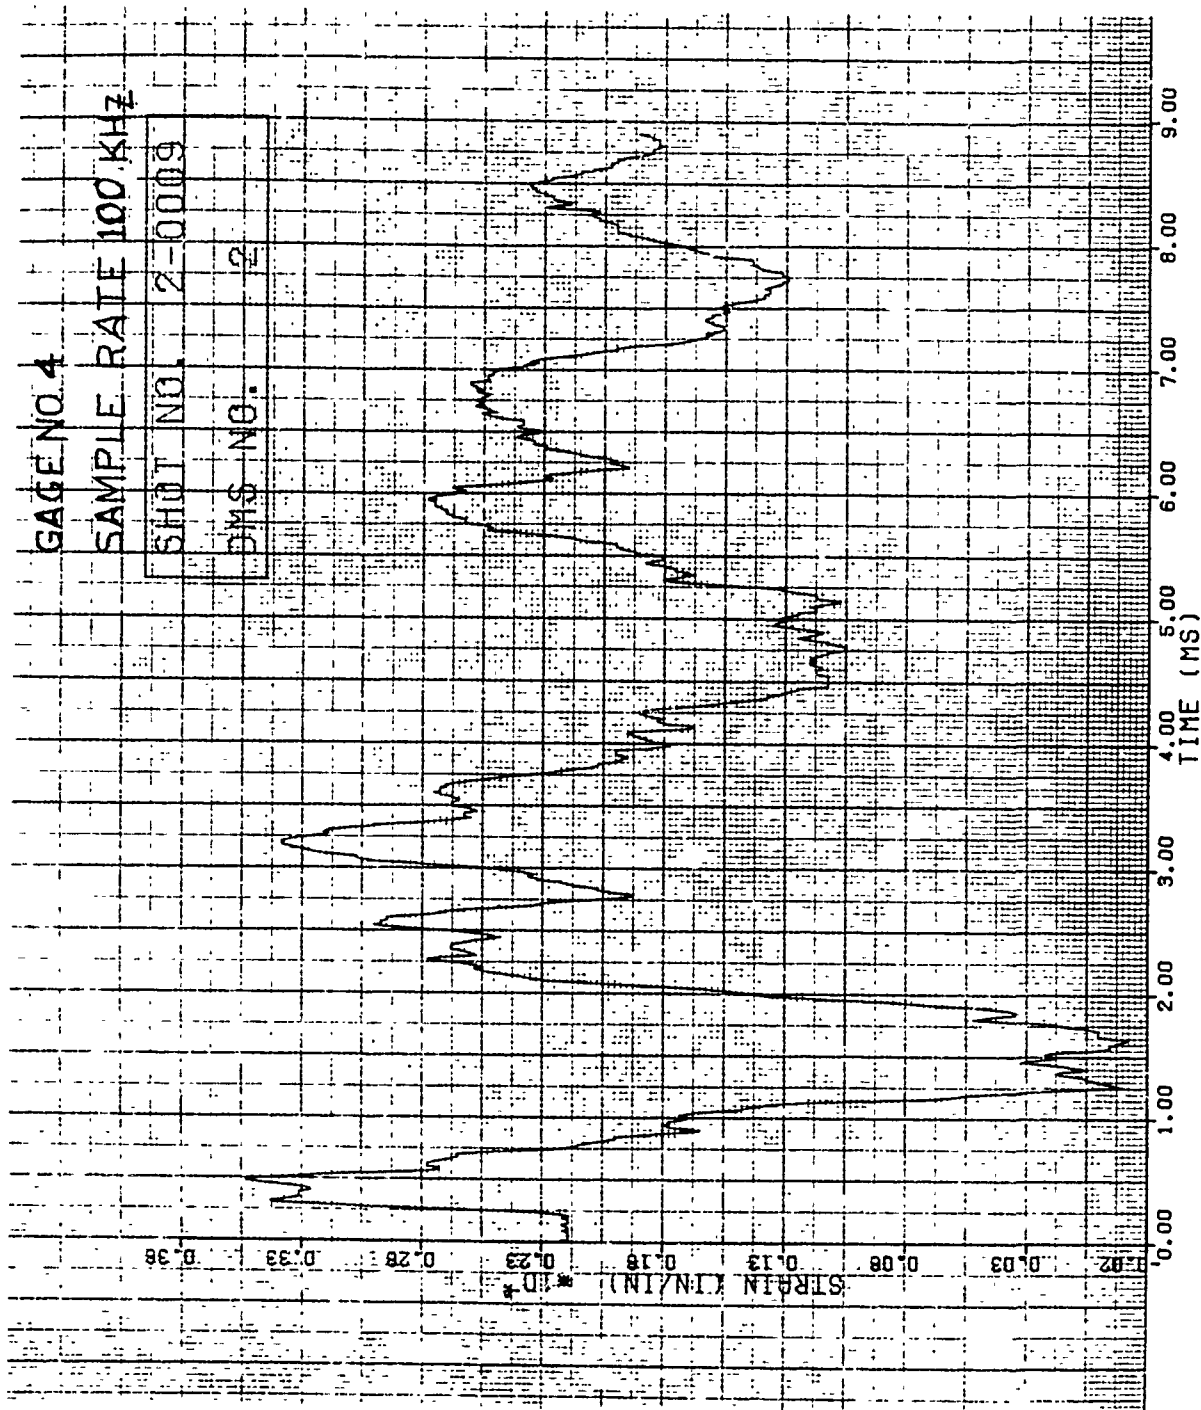
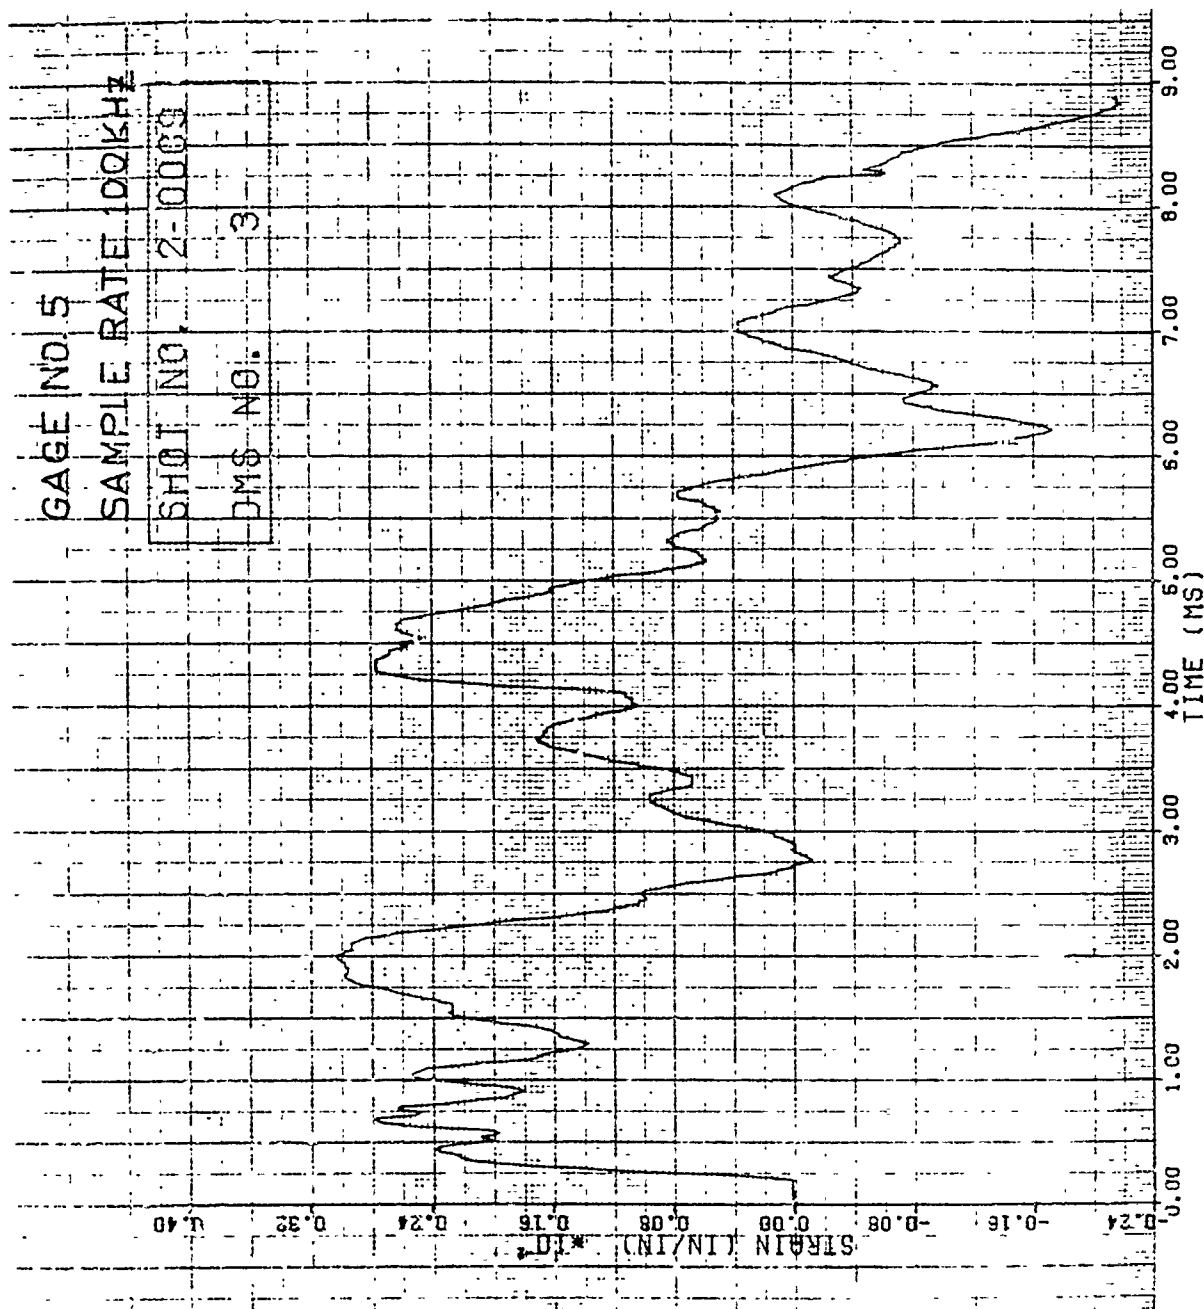
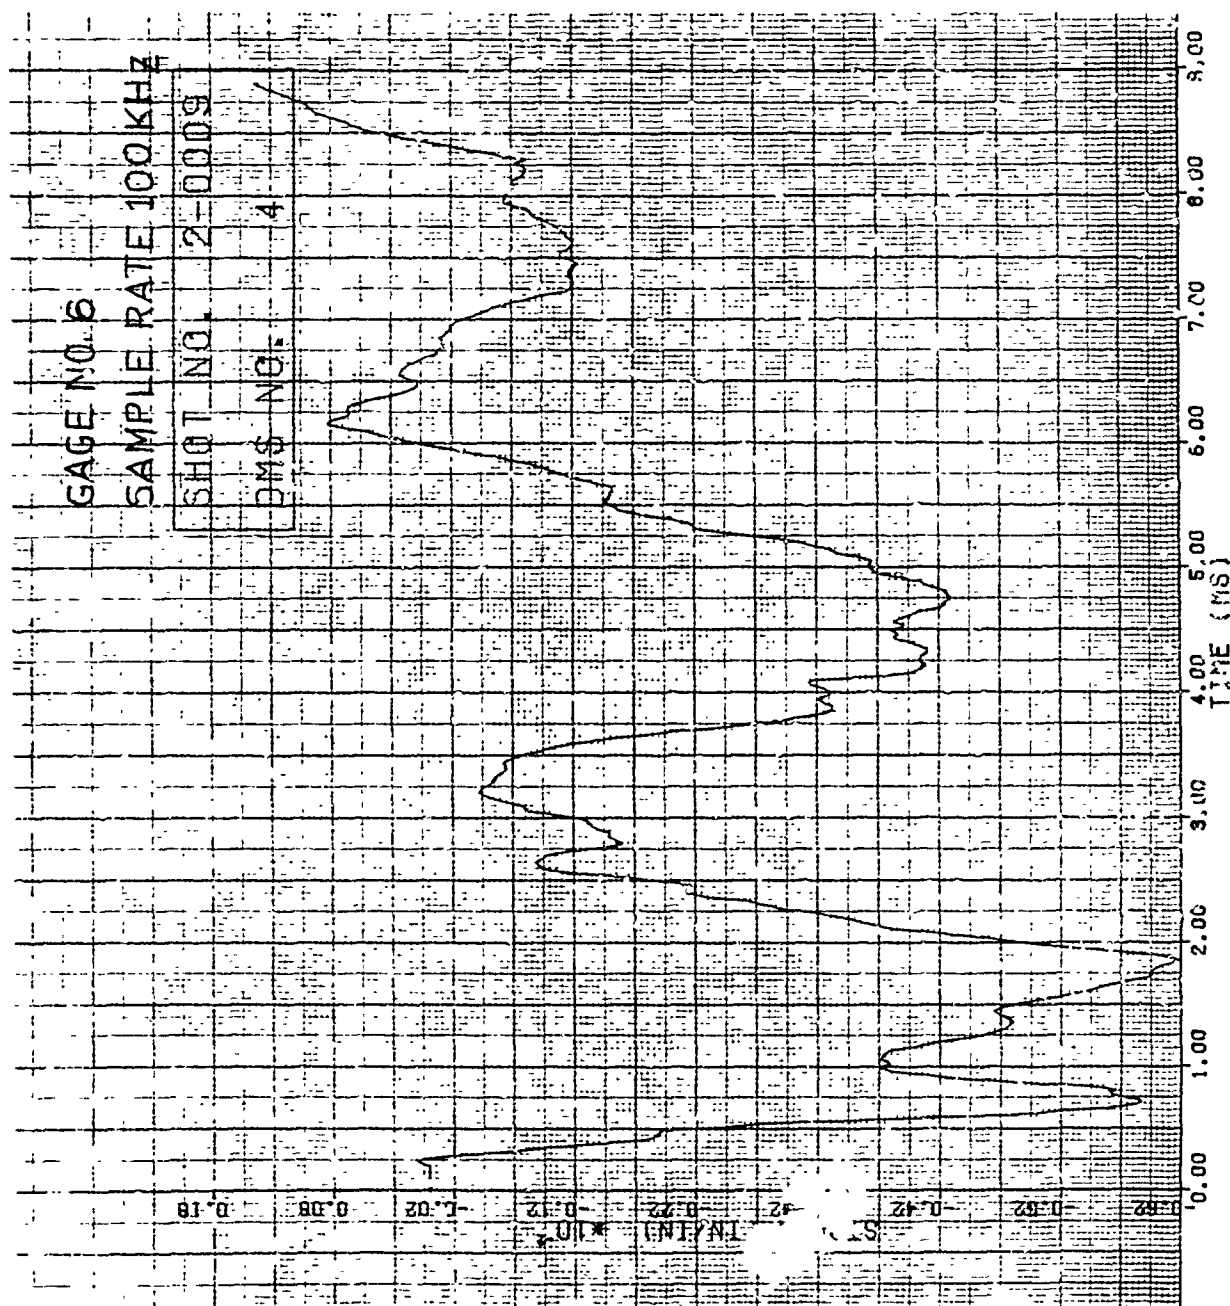
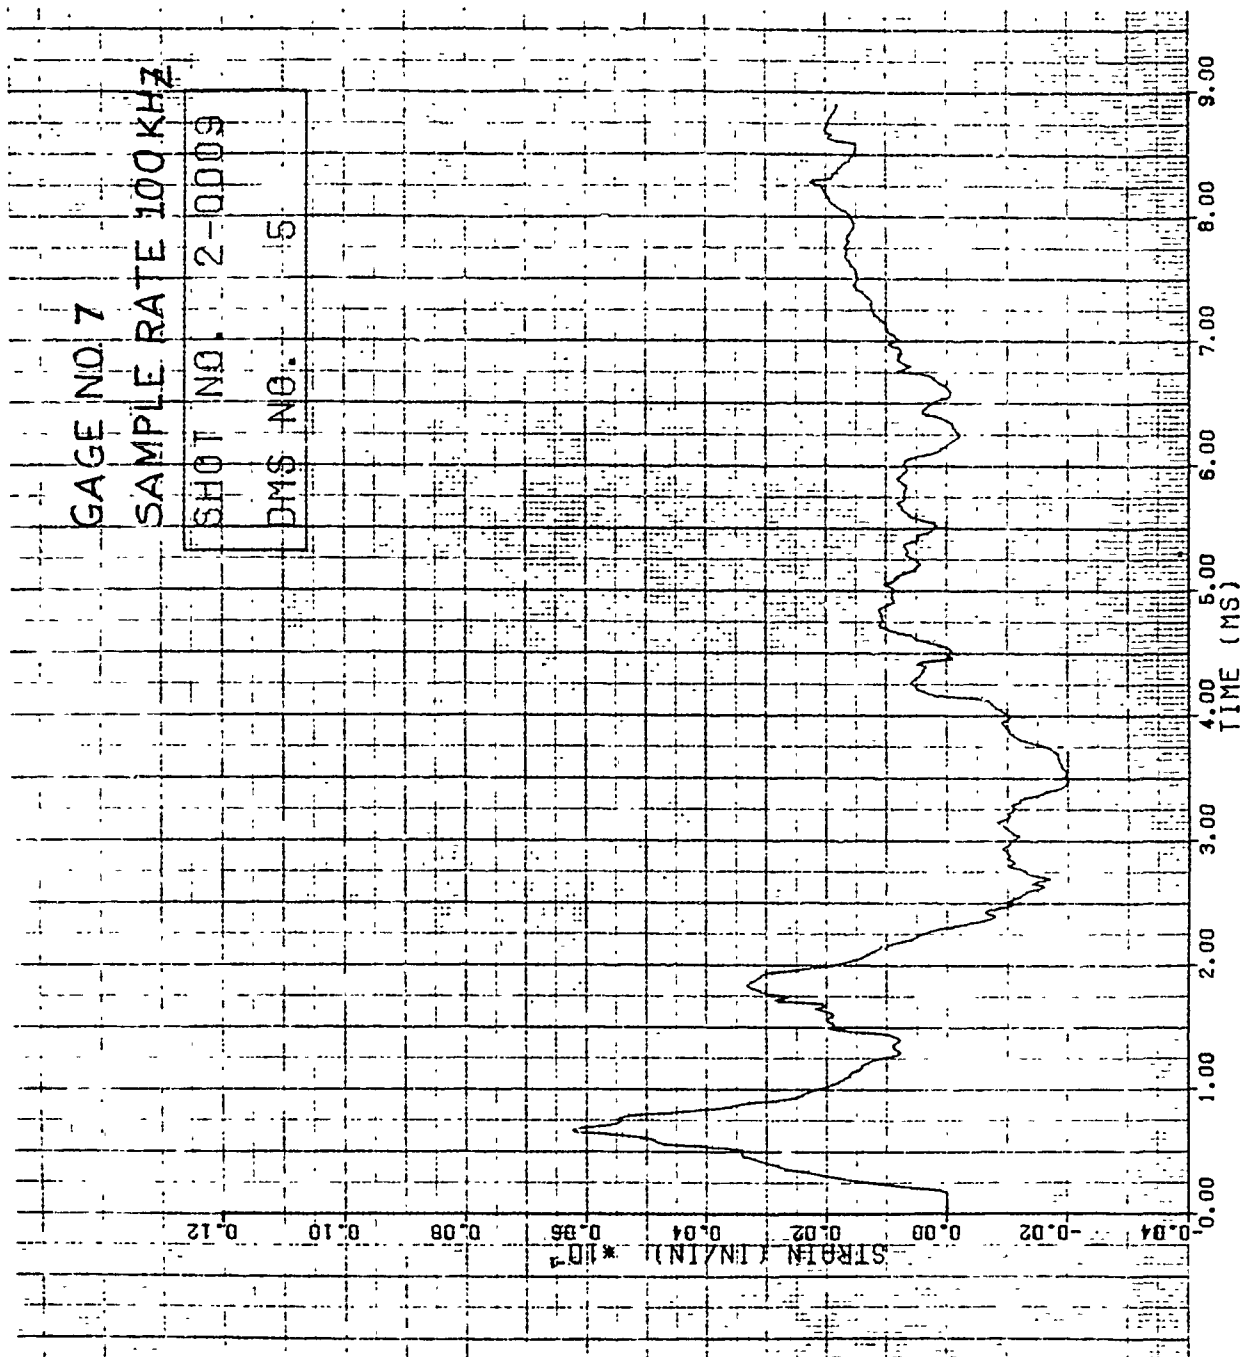
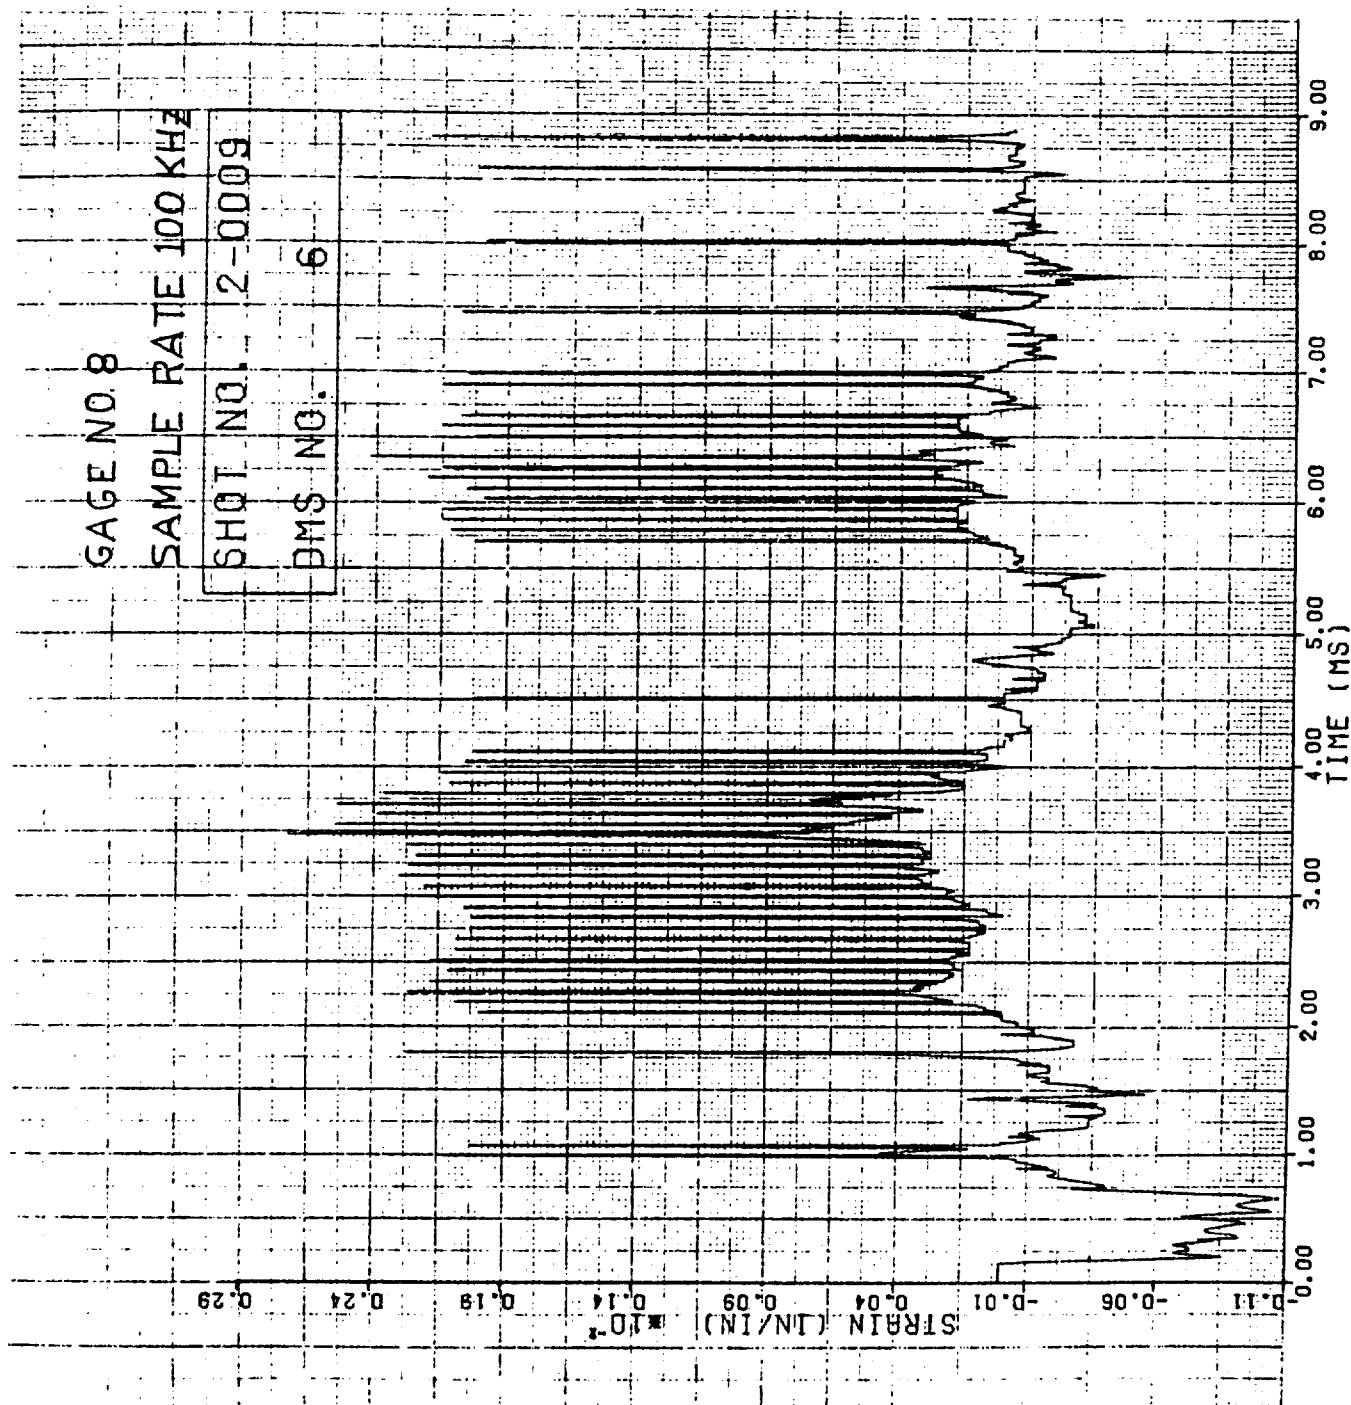
Typical strain data for this group of blades are given in Figures 204 through 209 for Shot 2-0009. The strain gage locations for this blade group is given in Figure 2A of Appendix A. Tension is denoted as a negative strain and compression as a positive strain for all impacts in this series of tests. As indicated above, no visible damage was received for Shot 2-0009 for an impact velocity of 161 m/s and an impact mass of 48.1 g.

Figure 204. Strain of Shot 2-0009 for Gage #1.

Figure 205. Strain of Shot 2-0009 for Gage #4.

Figure 206. Strain of Shot 2-0009 for Gage #5.

Figure 207. Strain of Shot 2-0009 for Gage #6.

Figure 208. Strain of Shot 2-0009 for Gage #7.

Figure 209. Strain of Shot 2-0009 for Gage #8.
